COESAM/PDEI-01-003

IDENTIFICATION OF SUBMERGED SIDE SCAN SONAR AND MAGNETIC TARGETS NAVAL STATION PASCAGOULA, MISSISSIPPI

FINAL REPORT

June 2001

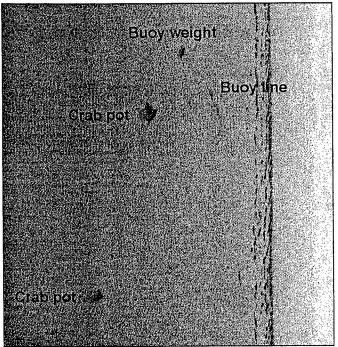
Figure 30. Sidescan sonar image of two crab pots, buoy weight and line.

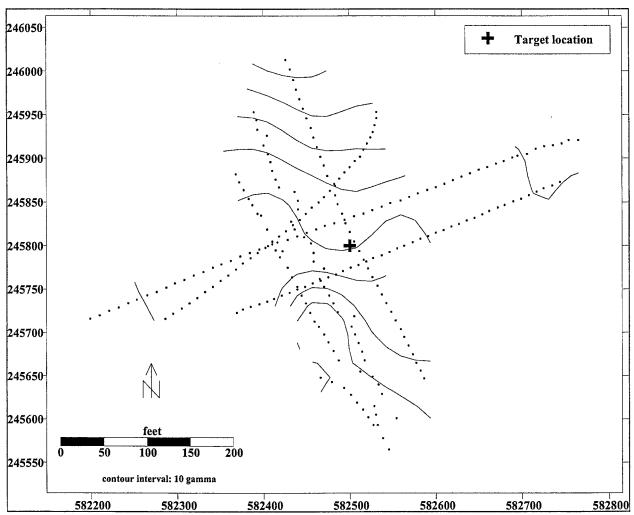
Figure 32. Magnetic contour map of Target 4. Note the relative paucity of magnetics at this location.

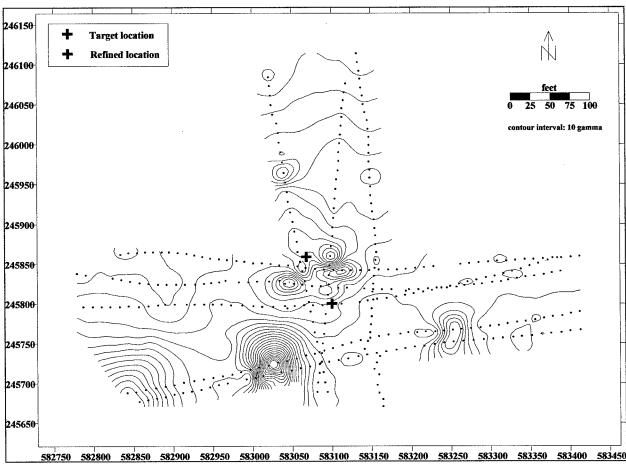
Target 6 was originally identified as three large magnetic anomalies, "each with a maximum gamma deviation of exceeding 120 gammas..." (McGehee et al. 2000:35). One of the three anomalies had an associated sidescan sonar return (Target 76B). After dropping a buoy on the coordinates provided by McGehee et al. (2000:38), the magnetometer was deployed and a series of eight tracklines run over the target area. Results of the refinement survey identified a cluster of anomalies near the buoyed location (Figure 36). While a larger anomaly was identified to the southwest of the buoy, review of the magnetic data identified it as a single point source only recreated on two passes heading east/west. Since this anomaly represents a monopole and has a relatively short duration, it was decided to investigate the cluster of anomalies located closer to the buoyed location.

Figure 36. Magnetic contour map of Target 6 showing the multi-component signature of the anomaly location as well as the refined location of the target.

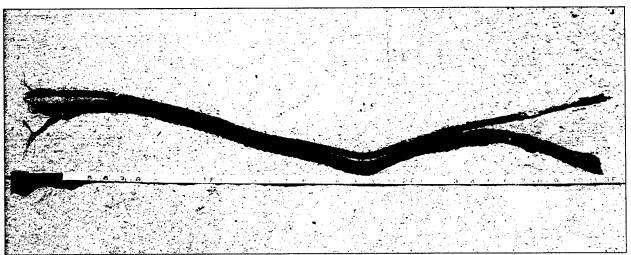
Initial diver investigation of Target 6 failed to identify the anomaly's source even after combing the area with a probe. Water depth on site is 27 feet. Since the source of the anomaly could not be identified during the initial dive it was determined to make a subsequent dive to attempt to locate the source of magnetics. A second dive on Target 6 identified the source of the anomaly as a lengthy section of wire cable slightly buried under the harbor sediment (Figure 37). During the attempt to determine the overall length of cable the diver identified a small coupling joining two sections of the cable together. After following the cable for over 25 feet it was decided that Target 6 simply represents a entangled modern wire cable lying approximately one foot under the harbor floor. Regarding the presence of wire cable in a industrial harbor Irion and Bond state:

Figure 37. Section of cable recovered by diver, identified as the source of magnetic Target 6.

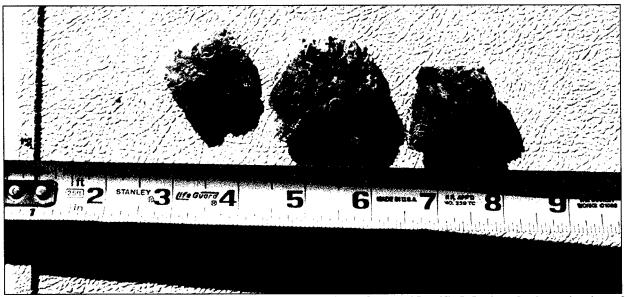
the diver identified a larger furrow than those located at the beginning of the dive. This furrow was almost two feet deep and extended in an east/west orientation for approximately 15 feet. This feature could also represent the source of either Target 22B or 33A.

Figure 38. Three small pieces of oyster shell recovered from furrow identified during the investigation of Targets 22B and 33A.
